Re: 0316060002 -- Cook County  
Dover Industrial Chrome  
ILD005125588  
RCRA Permit

<u>Section</u>	<u>Page</u>
EXECUTIVE SUMMARY .....	ES-1
1.0 INTRODUCTION .....	1
2.0 FACILITY DESCRIPTION .....	3
2.1 FACILITY LOCATION .....	3
2.2 FACILITY OPERATIONS .....	3
2.3 WASTE GENERATING PROCESSES .....	5
2.4 HISTORY OF DOCUMENTED RELEASES .....	9
2.5 REGULATORY HISTORY .....	10
2.6 ENVIRONMENTAL SETTING .....	11
2.6.1 Climate .....	11
2.6.2 Flood Plain and Surface Water .....	12
2.6.3 Geology and Soils .....	12
2.6.4 Groundwater .....	12
2.7 RECEPTORS .....	13
3.0 SOLID WASTE MANAGEMENT UNITS .....	15
4.0 AREAS OF CONCERN .....	21
5.0 CONCLUSIONS AND RECOMMENDATIONS .....	22
REFERENCES .....	28

B&V Waste Science and Technology Corp. (BVWST) performed a preliminary assessment and visual site inspection (PA/VSI) to identify and assess the existence and likelihood of releases from solid waste management units (SWMU) and other areas of concern (AOC) at the Dover Industrial Chrome facility in Chicago, Illinois. This report summarizes the results of the PA/VSI and evaluates the potential for releases of hazardous wastes or hazardous constituents from SWMUs and AOCs identified. In addition, a

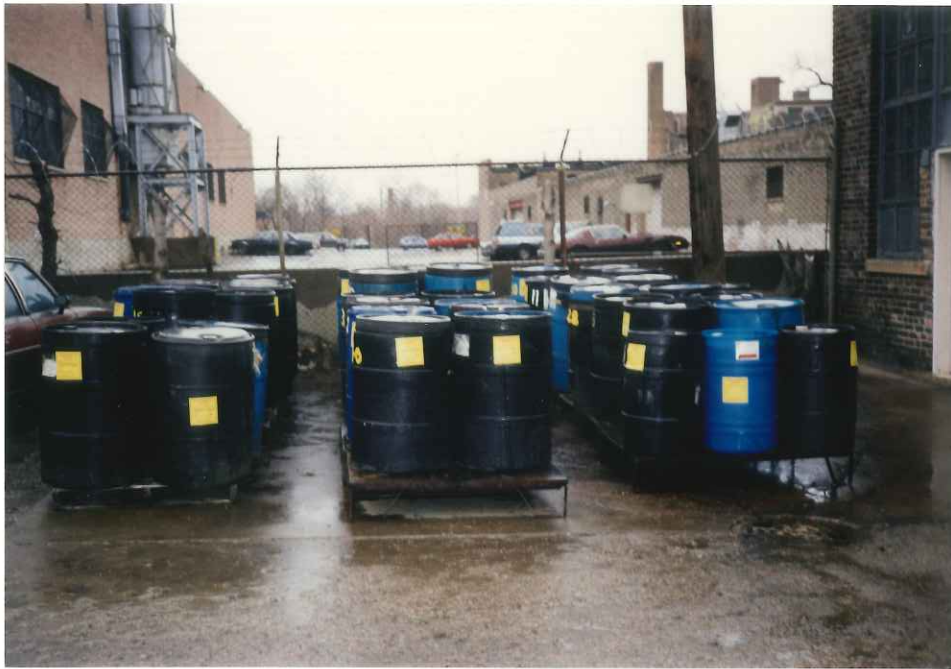
Location: SWMU 1  
 Date: 12/20/91

The potential is moderate for release of hazardous constituents to ground water from this facility. SWMU 1, the drum storage pad, has had one documented spill, according to Dr. Schrodtt. The concrete is cracked and stained; therefore, there is a possibility of ground-water contamination.

**Observations:** The unit contained evidence of releases due to discoloration of the concrete. The concrete is also cracked. This unit has no secondary containment. There were three rows of drums on skids totalling thirty-five 55-gallon drums and three 30-gallon drums.

There has been one documented spill at this unit, according to Dr. Schrodt. The concrete is cracked and stained, which indicates previous spills throughout this area.

Photograph No. 1  
 Orientation: East  
 Description: Drum storage pad and fence along the eastern border of property.

Recommendations: BVWST recommends that soil samples underneath and around the concrete pad be taken because of the past spill and the staining and cracks in the concrete.

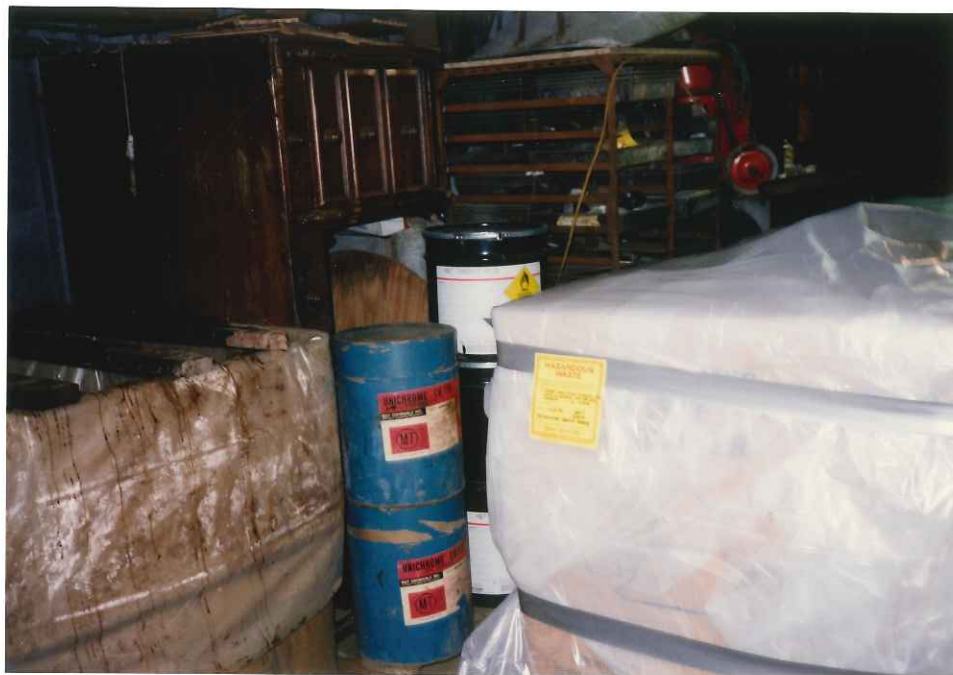
Location: SWMU 2  
 Date: 12/20/91

**Unit Description:** The hazardous waste container storage shed is located west of the drum storage pad and north of the building. The unit measures 18 x 24 feet. It is a metal shed with a concrete floor (see Photograph Nos. 2 and 3). Drums, cardboard boxes, miscellaneous materials, and equipment, are stored in the shed. Waste is stored in this unit for greater than 90 days.

During the VSI, the storage shed contained four cubic-yard containers of retention basin sludge in the center area; a cardboard box of chromium hydroxide to the right; behind that to the right of the shed, two 55-gallon drums of boric acid; to the left, a cardboard box container which contained chrome acid blower waste. The concrete floor did not appear to be cracked.

Photograph No. 2  
 Orientation: Northeast  
 Description: Inside of the hazardous waste container storage shed.

Recommendations: BVWST recommends no further action for this unit.

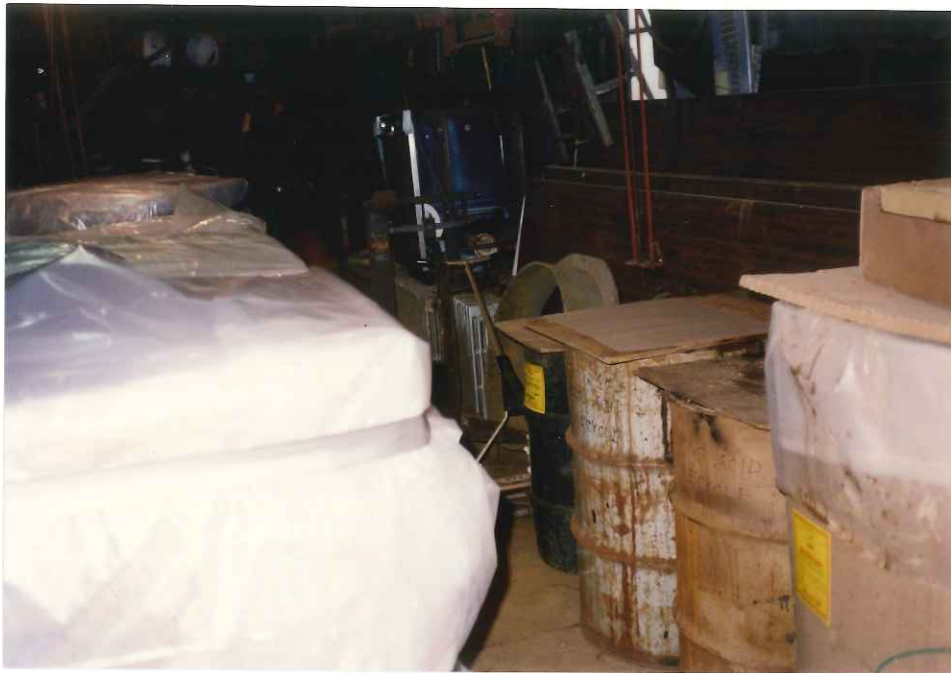
Location: SWMU 2  
 Date: 12/20/91

Photograph No. 3  
 Orientation: Northeast  
 Description: Inside of the hazardous waste container storage shed.

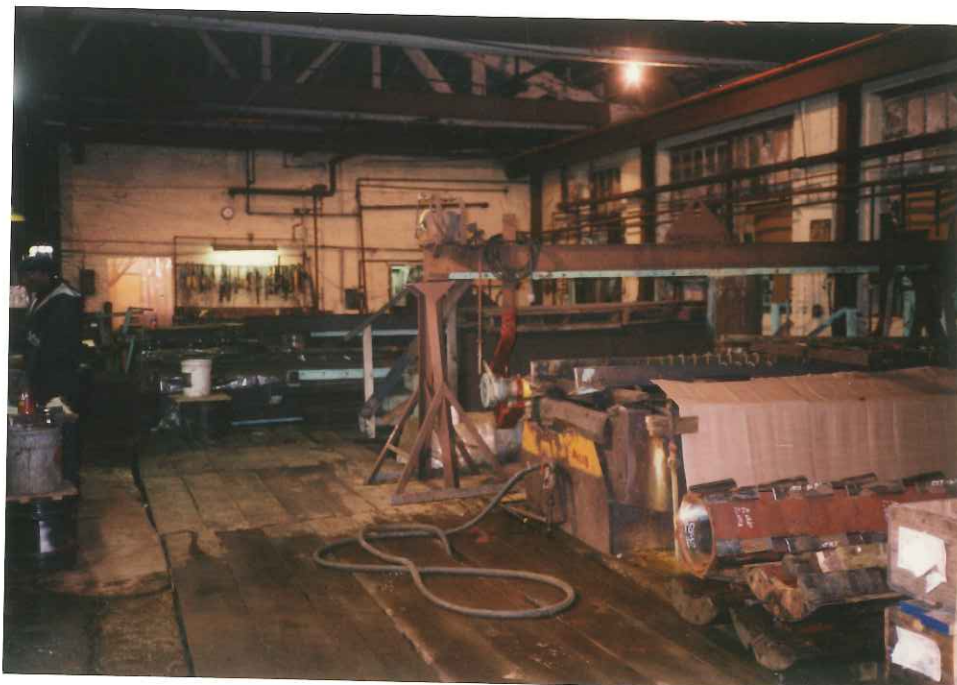
Location: SWMU 3  
 Date: 12/20/91

Observations: During the VSI, BVWST observed the plating baths to be intact. Part of the plating area is covered with wood plans, where the sump pumps are located. No evidence of a release was noted.

Photograph No. 4  
 Orientation: Northwest  
 Description: Plating Area.

BVWST recommends that the facility hook the pumps into some type of wastewater treatment or circulate it back into the baths instead of discharging it into the storm sewer drain. Based on the manner of release of chromic acid on May 31, 1991, into the storm sewer drain, water treatment or recirculation would prevent a recurrence.

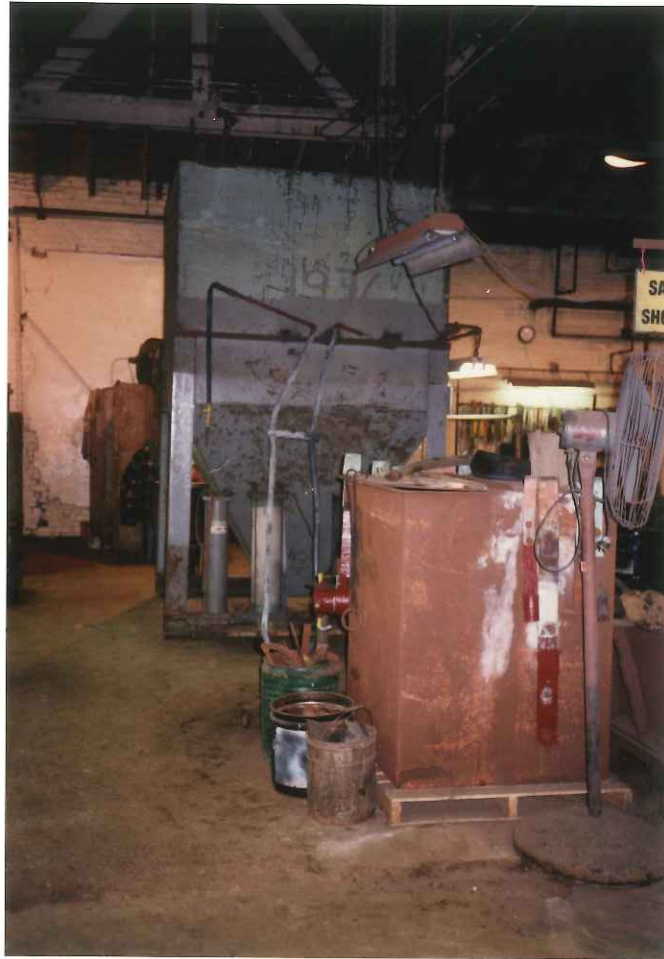
Location: SWMU 4  
Date: 12/20/91

**Observations:** BVWST observed that this unit has been dismantled and sits on a concrete floor. The floor did not appear to be stained or cracked.

Photograph No. 5  
Orientation: Northwest  
Description: Area of the dismantled wastewater treatment system.

Recommendations: BVWST recommends no further action for this unit.

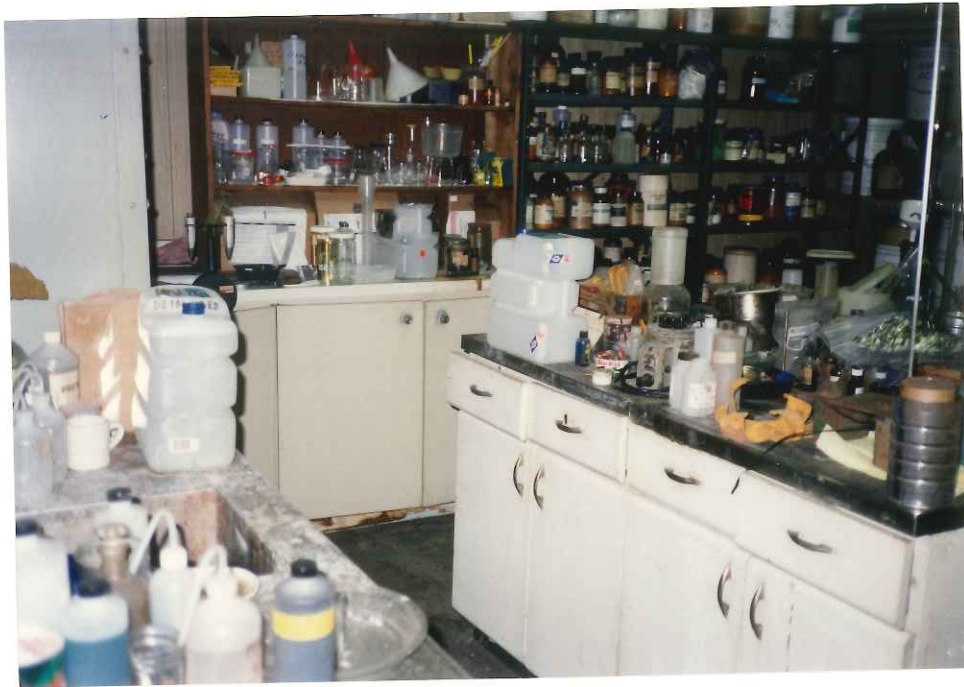
Location: SWMU 5  
 Date: 12/20/91

Date of Startup:	This unit began operations in 1978.
Date of Closure:	This unit is active.
Wastes Managed:	This unit manages flakes of waste copper, iron and chrome.
Release Controls:	The flakes are retained in jars and plastic bags stored in the laboratory.
History of Documented Releases:	No releases from this unit has been documented.
Observations:	This unit has a concrete floor. BVWST did not observe any evidence of a release. The floor did not appear to be stained or cracked.

Photograph No. 6  
 Orientation: Southeast  
 Description: Inside of the laboratory.

Recommendations: BVWST recommends no further action for this unit.

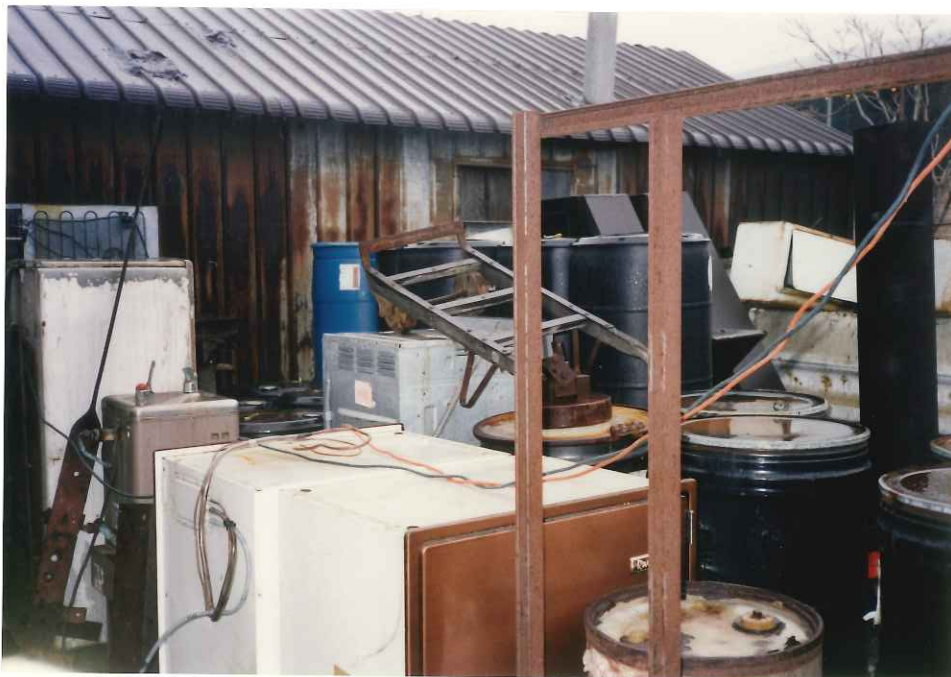
Location: AOC 1  
 Date: 12/20/91

The potential is moderate for a release of hazardous constituents to the onsite soil from SWMU 1 and AOC 1. Due to the spill earlier this year, soil on the eastern portion of SWMU 1 may be contaminated from the contents of the spill. The pile of old equipment surrounding AOC 1 may puncture or knock down the drums.

This unit is part of a concrete apron, located east of the hazardous waste container storage shed. This unit consists of several 55-gallon drums, lined with plastic bags, containing old acid bricks. These acid bricks were used to line the bottom of the chromium-plating baths. The bricks were used as a cushion for the baths in case a roller, while being plated, accidentally fell in a bath. The bricks would prevent the roller from puncturing the bath. These bricks were replaced with new bricks. Dr. Schrodt stated that these bricks will be used in the baths in the future. He stated that the bricks are coated with chromium. The storage area where these drums are located is very unkempt. Old equipment is piled around and on top of these containers. There is a very high possibility of these drums becoming punctured or knocked over by the careless stacking of the old equipment in this area (see Photograph No. 7).

Photograph No. 7  
 Orientation: Northwest  
 Description: Fiber drums of old acid bricks and surrounding debris.

Recommendations: BVWST recommends that the facility isolate the drums from the old equipment piled in this area. This action will greatly reduce the potential of chromium release for this unit.
